## Unit Assessment Sheet

**2204143 21ft x 9ft AV Drying Room**

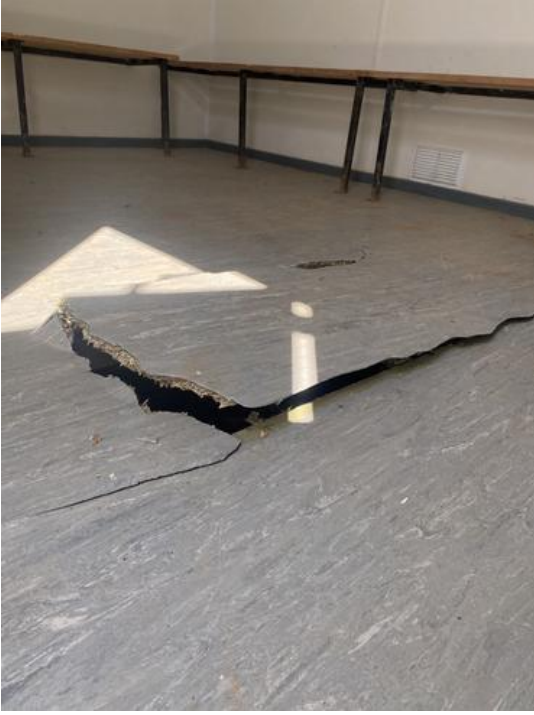
Photo 11

Internal Inspection		18 / 28 (64.29%)
Celling		Good
Walls		Good
Windows		Good
Partition Doors / Keys		N/A
Trims		Good
Floor		Bad
Score justification:		Damaged/Cracked floor
  <p>Photo 11</p>		
Other fittings		N/A
Electrics		Good
General Condition		Good
Overall Internal Assessment Summary		Floor structurally damaged, Clean unit, unit is water tight
