Unit Assessment Sheet

2204157 24ft x 9ft AV Office Unit

Restroom:	N/A
General	
Fleet No. Supplier:	BV0660
Fleet No. JCPSA:	2204157
Transport Company:	Other
Date:	17.10.2023 13:21 BST
Assessed by:	Allan Galwas

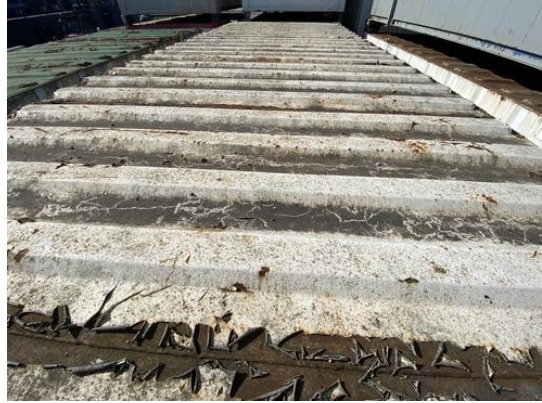
External Inspection		21 / 33 (63.64%)
Roof		Fair

Photo 14	
Score justification:		Rusty, showing age, Unit is dry inside
Paint		Fair
Score justification:		Paint starting to rust + paint cracked
Walls		Good
Floor Beams		Fair
Score justification:		Hole in the floor, structurally damaged

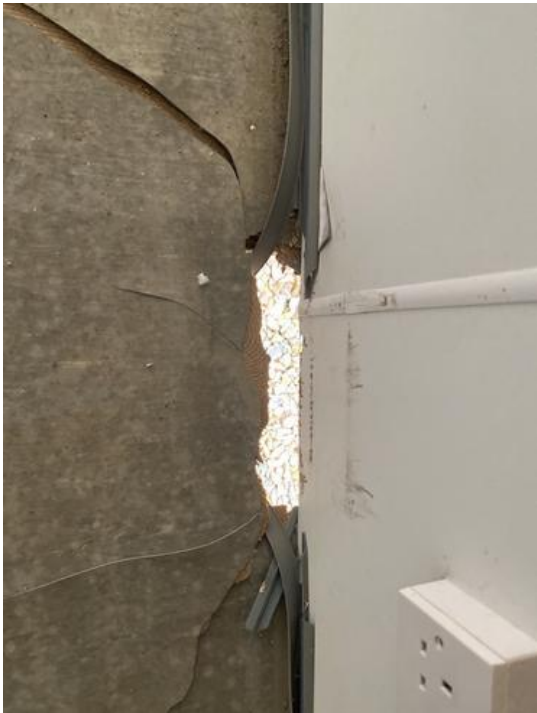
Photo 15	
Windows		Good
Shutters		Good
Doors		Good
Keys		Yes
How many keys per lock are included?		1
General Condition		Fair
Score justification:		Damaged floor + Paint
Overall External Assessment Summary		Damaged floor + Paint, Unit showing age

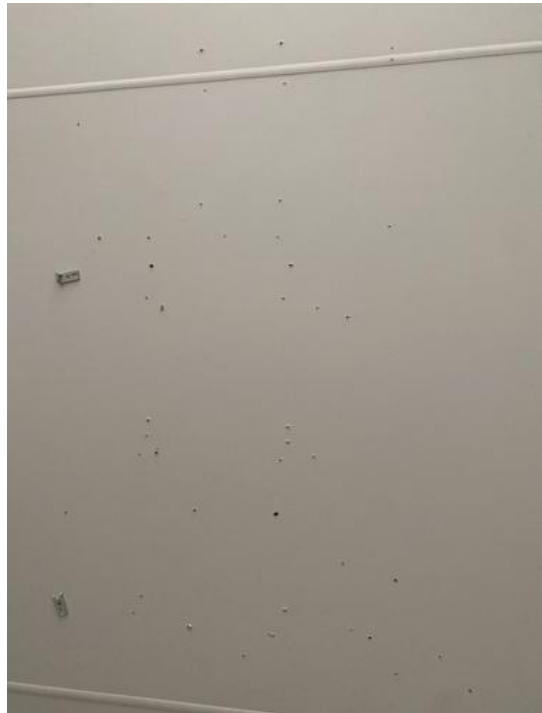
Photo 16

Celling	Good
Walls	Fair

Lots of tiny pin holes

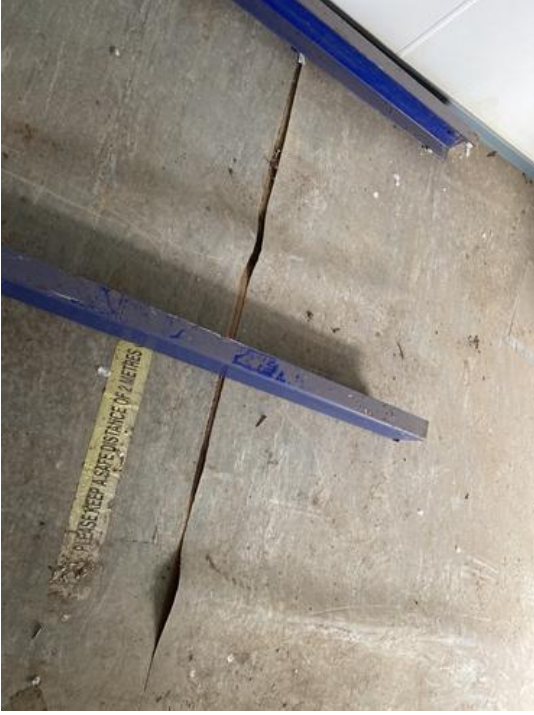
Photo 17

Trims	Good
Floor	Poor

Vinyl coming off + structurally damaged floor
