Unit Assessment Sheet

2210380 21ft x 9ft Used Canteen

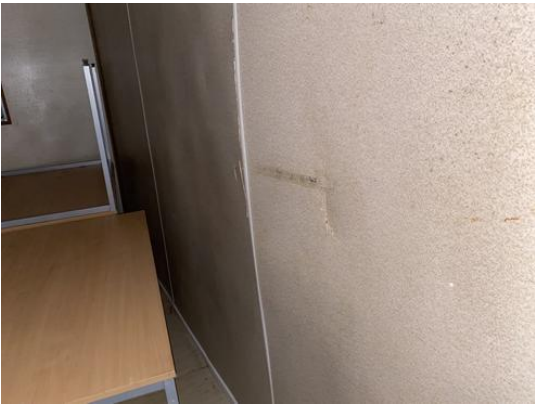
Photo 11

Internal Inspection		23 / 32 (71.88%)
Ceiling		Good
Walls		Fair
Score justification:	Wall panel warped/damaged
