Unit Assessment Sheet

2211387 21ft x 9ft Used Office

Date: **19.10.2023 12:16 BST**

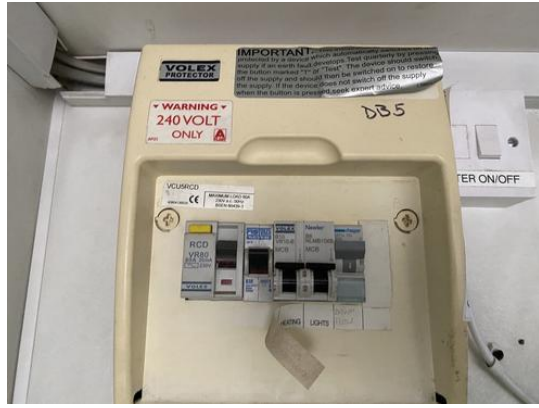
Photo 8	
Lighting:	Fluorescent LED light
Number of lights:	3
Number of electrical sockets:	4
Number of electrical switches:	4
Heating:	Convactor heater

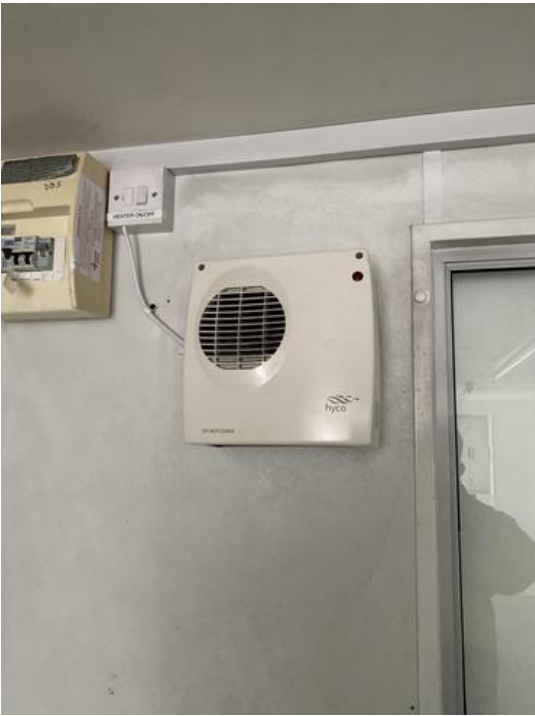
Photo 9	
Number of heaters:	1
Internal	2 / 2 (100%)
Rooms:	1
Floor finish:	Vinyl
Wall finish:	Plasterboard
Kitchen unit:	N/A
Restroom:	N/A
General

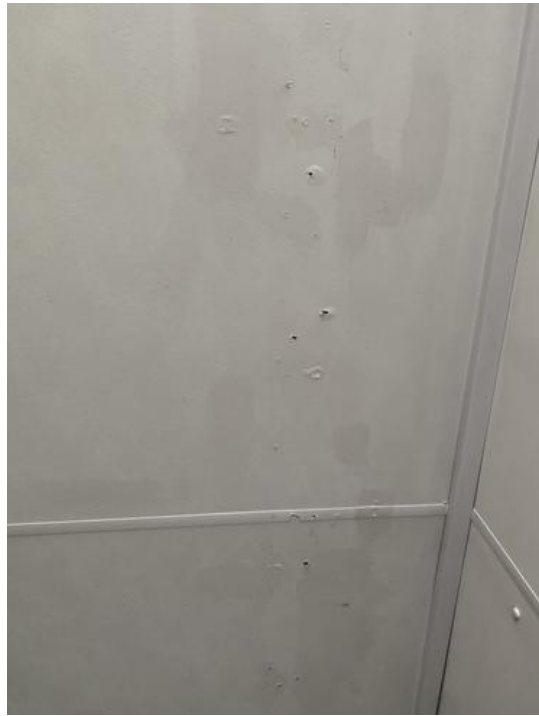
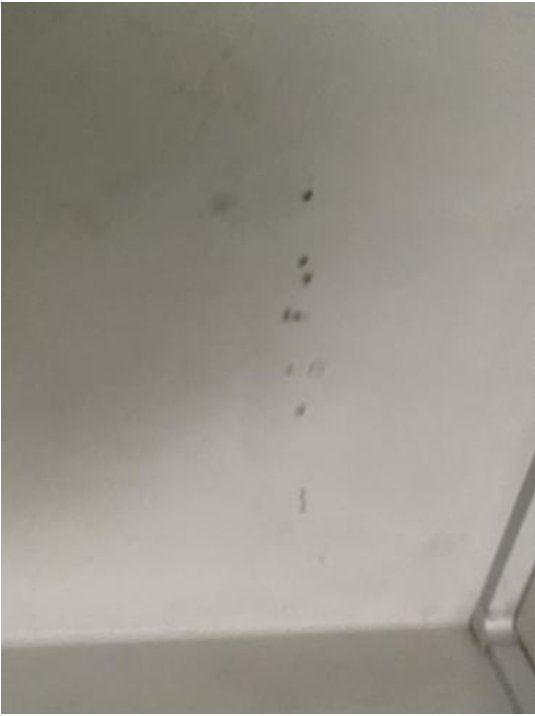
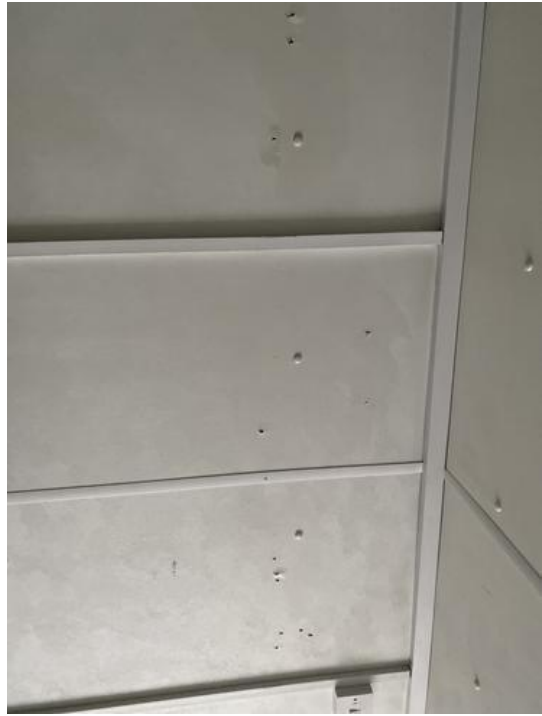
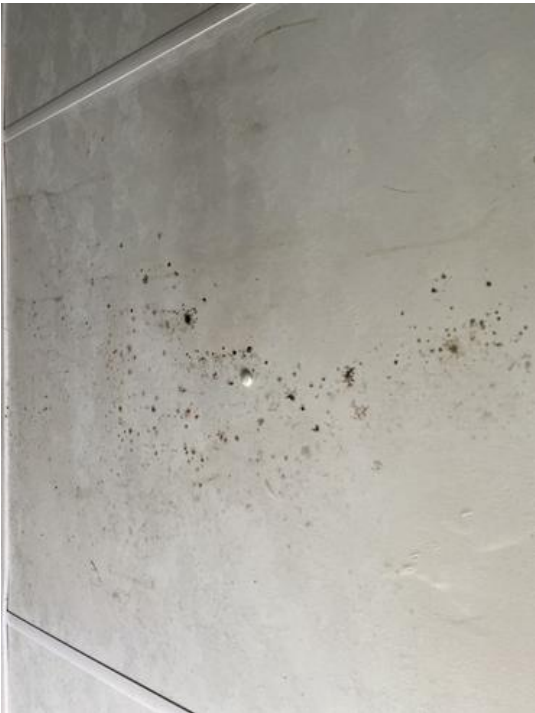
Internal Inspection		20 / 28 (71.43%)	
Ceiling		Good	
Walls		Fair	
Score justification:		Pin holes in a few of the wall panels, bit of mould

Photo 10	Photo 11	Photo 12	Photo 13
Windows		Good	
Partition Doors / Keys		N/A	
Trims		Good	
Floor		Good	
Other fittings		N/A	
Electrics		Good	
General Condition		Good	
Overall Internal Assessment Summary		Clean + Dry unit, Stain on vinyl, Structurally sound
