Unit Assessment Sheet

2302024 20ft x 9ft Used AV
Canteen Dryer

Heating:	Convector heater
Number of heaters:	1
Kitchen unit:	Yes
Water heater:	Oversink
Restroom:	N/A
Color:	N/A
Lifting:	ISO Corners Top Forklift pockets
Fleet No. Supplier:	MS316189
Fleet No. JCPSA:	2302024
Maximum external dimension (eg. including legs, pipes, facade/cladding, AC units) (Length x Width X Height)	
Transport Company:	Other
Date:	14.09.2023 11:17 BST
Assessed by:	Allan Galwas

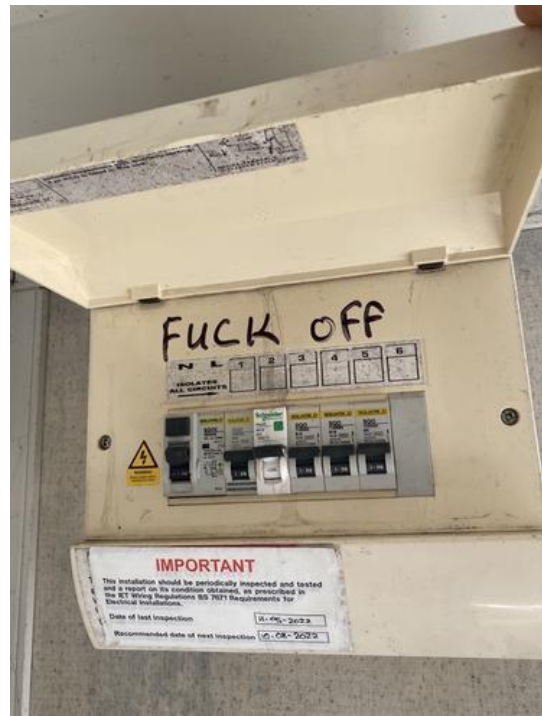
Photo 10

Power in:

Isolator switch

Consumer unit:

5 Way

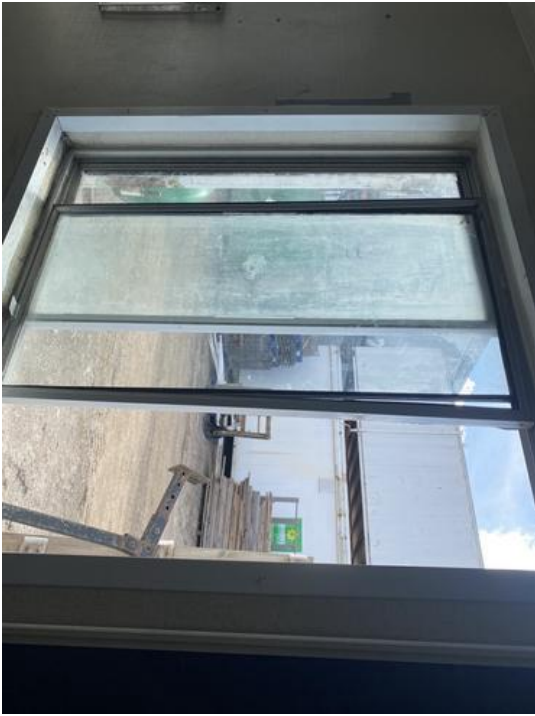
Photo 11

External Inspection	1 flagged, 12 / 29 (41.38%)
Roof	Poor
Score Justification:	Lots of rust + cannot see entire roof due to restricted access
Paint	Poor
Score justification:	Lots of rust all around + showing age
Walls	Good
Floor Beams	Good
Windows	Bad
Score justification:	Windows doesn't close

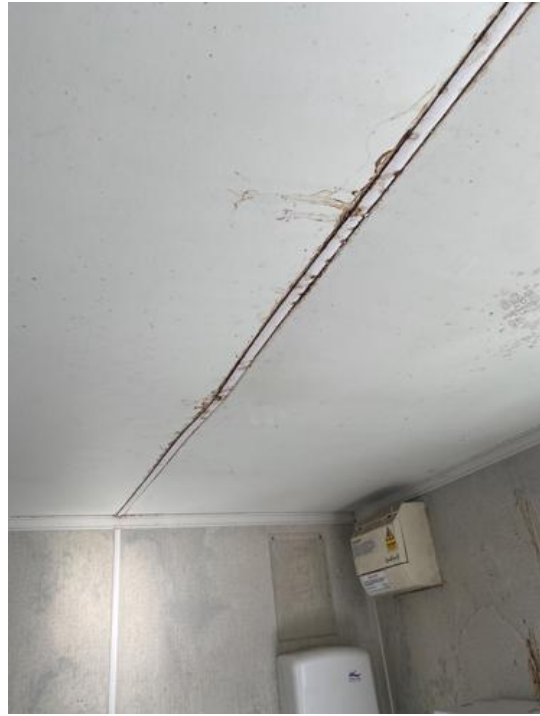
Photo 12

Celling

Fair

Rust on edges (signs of leak)

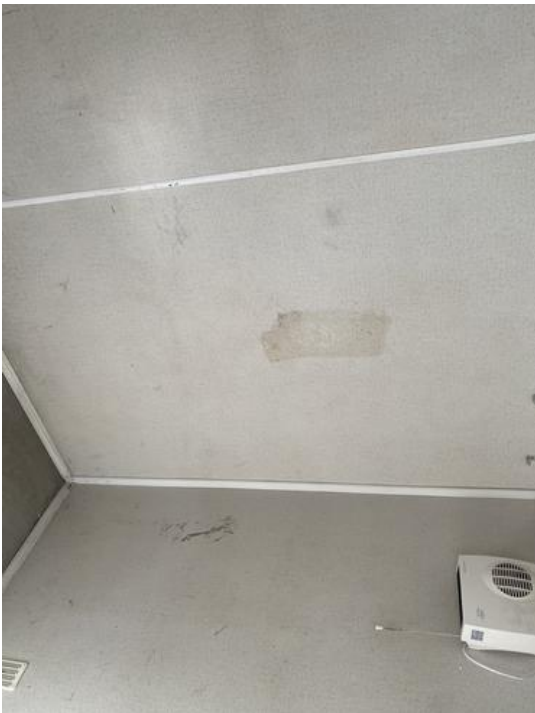
Photo 13

Walls

Fair

Mouldy + marks all over

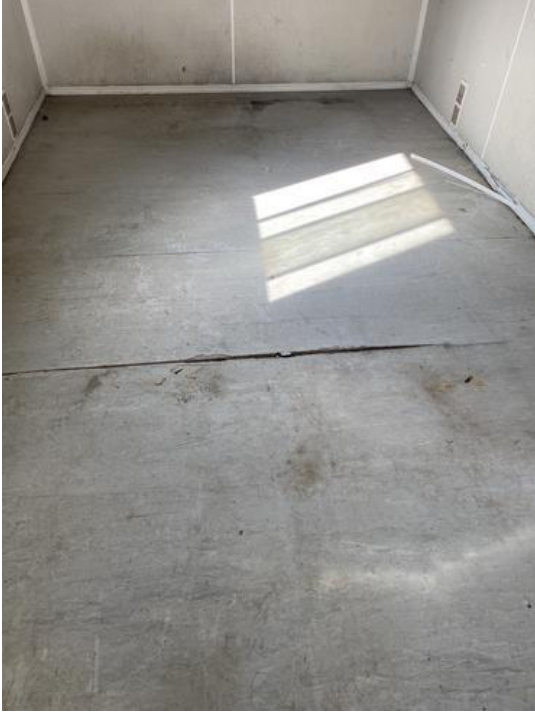
Photo 15

Floor

Fair

Cracked floor
