Unit Assessment Sheet

2204197 24ft x 9ft Used AV Toilet Block

Used AV Toilet Block

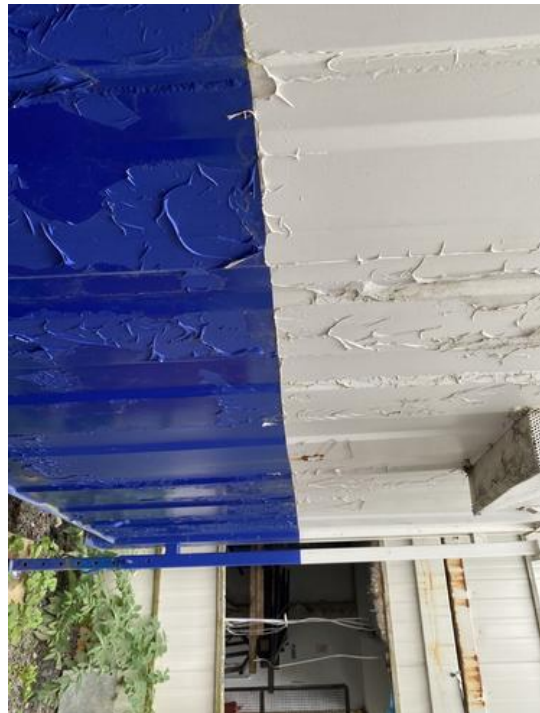
Photo 10	
Score justification:	Damaged paint + Rust	
Walls		Good
Floor Beams		Good
Windows		Good
Shutters		N/A
Doors		Fair
Left door difficult to open		
Keys		Yes
Only one door has a key		
How many keys per lock are included?		1
General Condition		Fair
Score justification:	Damaged paint + missing key	
Overall External Assessment Summary	Fair Condition paint + rust needs treating, unit showing age

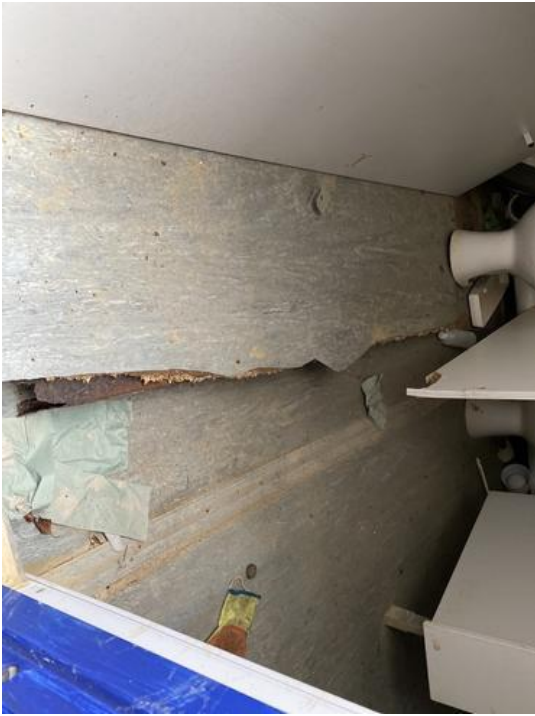
Internal Inspection	3 flagged, 26 / 56 (46.43%)
Celling	Bad
Score justification:	Missing panel + insulation hanging out
Walls	Good
Windows	Good
Partition Doors / Keys	Bad
Score justification:	Missing key
Trims	Good
Floor	Bad
Score justification:	Hole in the floor, structurally damaged

Photo 11	
Other fittings	Toilet
Toilet/WC	Bad
Two missing toilets + one not installed properly

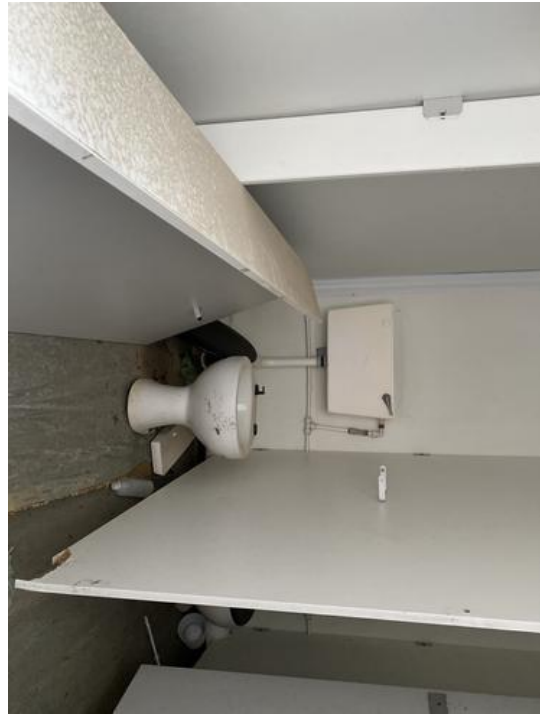
Photo 12

Two missing toilets + one not installed properly

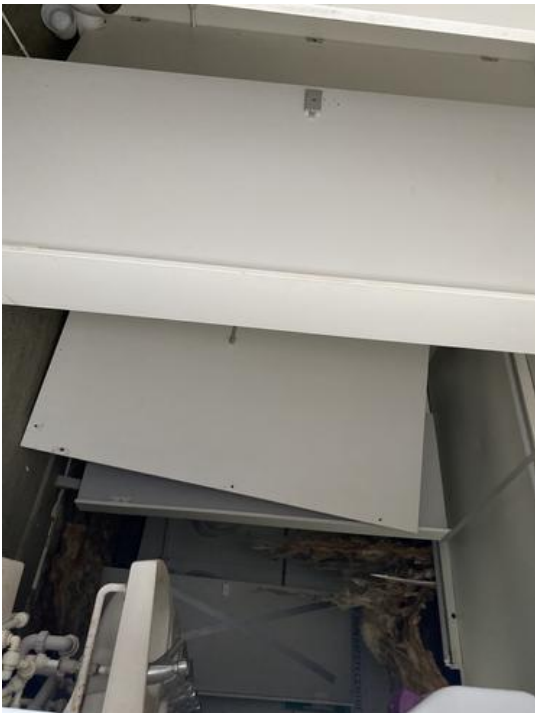
Photo 13

Has fallen apart

Photo 12	
Toilet cubicles	Bad
Has fallen apart
