Unit Assessment Sheet

**2209346 13ft x 9ft Used
Thurston 2+1 Jack Leg Toilet
Block**

Type:	2 Gents + 1 Ladies
General	
Fleet No. Supplier:	A605819
Fleet No. JCPSA:	2209346
Transport Company:	Other
Date:	19.10.2023 08:18 BST
Assessed by:	Allan Galwas

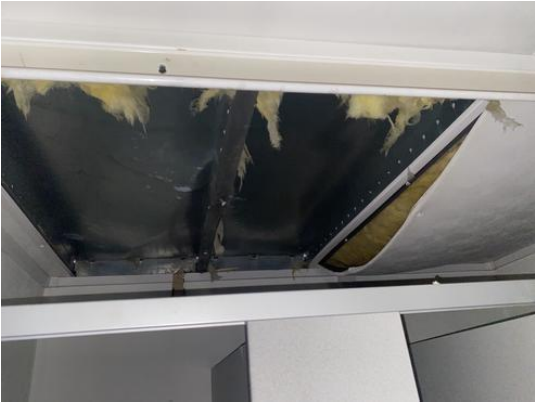
Photo 9

Roof Insulation:

2 missing panels

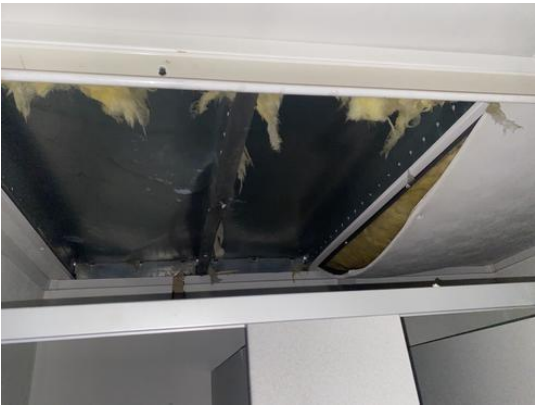
Photo 11

Internal Inspection		36 / 52 (69.23%)
Celling		Poor
Score justification:	Two missing ceiling panels + insulation
