Unit Assessment Sheet

2305130 12ft x 9ft 2+1 Used AV Toilet Block

Fleet No. Supplier:	N/A
Fleet No. JCPSA:	2305130
Transport Company:	Other
Date:	18.10.2023 13:25 BST
Assessed by:	Allan Galwas

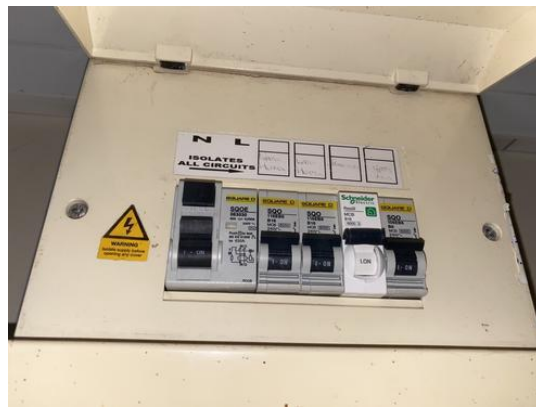
Photo 12		
Lighting:		Fluorescent light
Number of lights:		2
Number of electrical sockets:		0
Number of electrical switches:		3
Heating:		N/A
Number of heaters:		0
Internal		2 / 2 (100%)
Rooms:		2
Floor finish:		Vinyl
Wall finish:		Plasterboard
Kitchen unit:		N/A
Restroom:		Yes
Type:		2 Gents + 1 Ladies
General

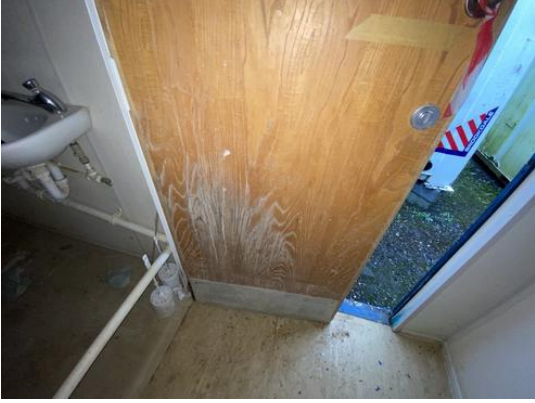
Photo 13

No keys for internal door, mould starting to show

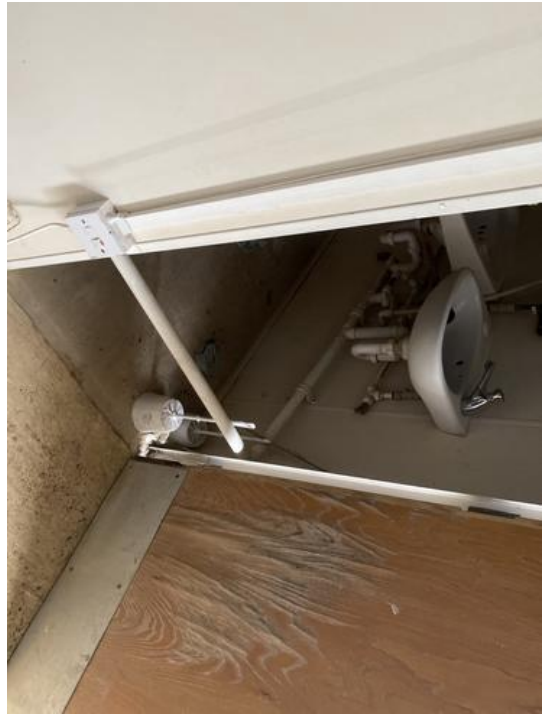
Photo 14

Pipe blocking partition entrance, structurally sound.
