Unit Assessment Sheet

2210373 24ft x 9ft Used 4+1 Toilet Block

Date: 15.11.2023 10:48 GMT

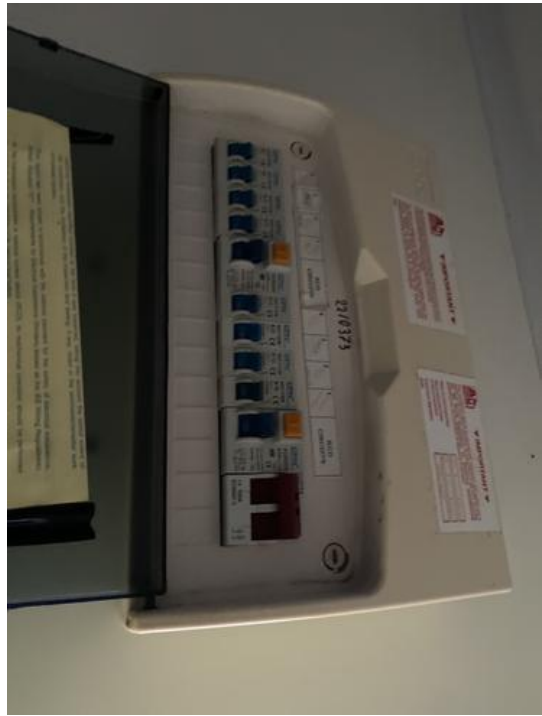
Photo 10		
Lighting:		Fluorescent light
Number of lights:		4
One missing		
Number of electrical sockets:		0
Number of electrical switches:		6
Heating:		N/A
Number of heaters:		0
Internal		2 / 2 (100%)
Rooms:		2
Floor finish:		Vinyl
Wall finish:		Plasterboard
Kitchen unit:		N/A
Restroom:		Yes
Type:		4 Gents + 1 Ladies
General

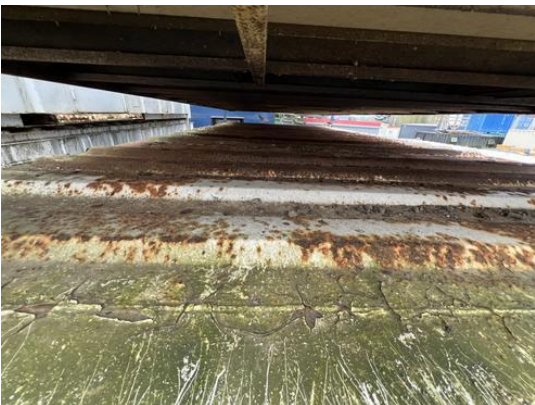
Photo 11

<p>Photo 11</p>		
Score justification:	Extremely rusty, no signs of leaks	
Paint		Fair
Score justification:	Old layer of paint starting to show, unit showing age	
Walls		Good
Floor Beams		Good
Windows		Good
Shutters		N/A
Doors		Good
Keys		Yes
How many keys per lock are included?		3
General Condition		Good
Overall External Assessment Summary	Structurally sound, paint + external walls showing age

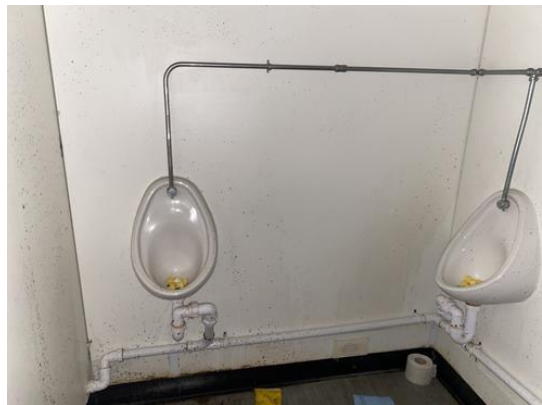
Photo 12	
Score justification:		Wall panels mouldy
Windows		Good
Partition Doors / Keys		Good
Trims		Good
Floor		Fair

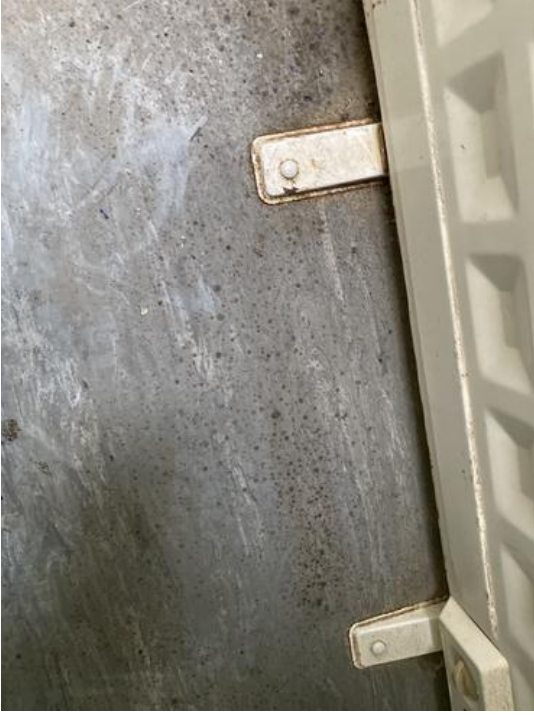
Photo 13	
Score justification:		Slight mould
Other fittings		Toilet
Toilet/WC		Good
Toilet cubicles		Good
Cistern		Good
Handwash Basin		Good
Urinals		Good
Water heater		Good
Electrics		Good
General Condition		Good

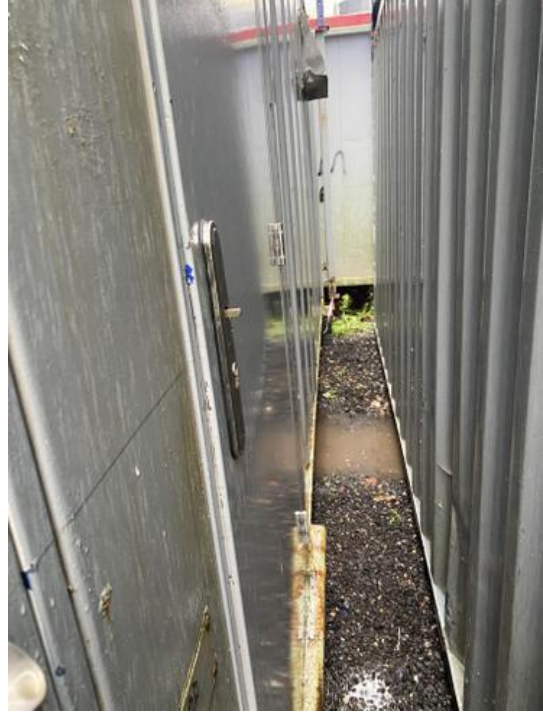
Photo 14

Mould on walls + floor, structural sound, dry unit
