Unit Assessment Sheet

**2303096 21ft x 9ft Used AV
Drying Room**

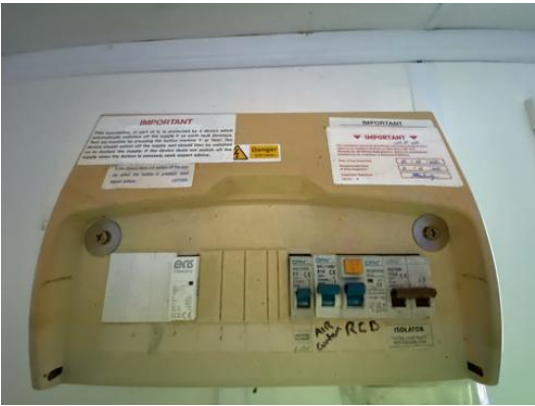
Photo 9	
Lighting:	Fluorescent light
Number of lights:	3
Number of electrical sockets:	0
Number of electrical switches:	1
Heating:	Downflow heater
(Needs to be tested might not work)	
Number of heaters:	1
Internal	2 / 2 (100%)
Rooms:	1
Floor finish:	Vinyl
Wall finish:	Plasterboard
Kitchen unit:	N/A
Restroom:	N/A
General	
Fleet No. Supplier:	BV0913
Fleet No. JCPSA:	2303096

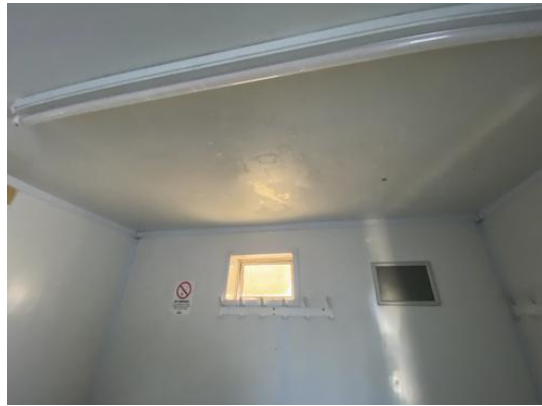
Photo 10

Internal Inspection		18 / 28 (64.29%)
<p>Celling</p> <p>Leak coming from roof, ceiling panels leaking with water.</p>

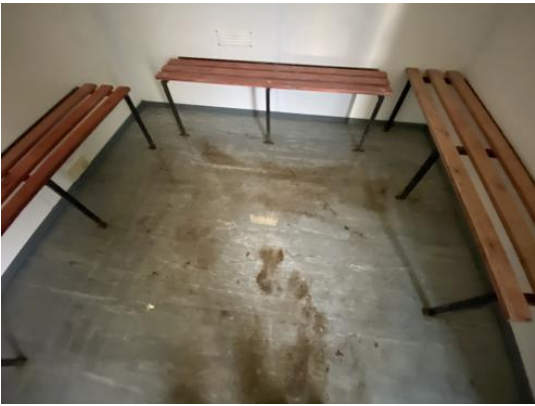
Photo 11

<p>Photo 11</p>		Fair
Score justification:	Damp unit, vinyl beginning to come due to water damage.	
Other fittings		N/A
Electrics		Good
General Condition		Fair
Score justification:	Leaking unit, damp floor	
Overall Internal Assessment Summary	Damaged internally form leak, unit showing it's age.
