# Unit Assessment Sheet

2307165 16ft x 9ft Used 3+1 Toilet Block

**Date:** 14.11.2023 11:47 GMT

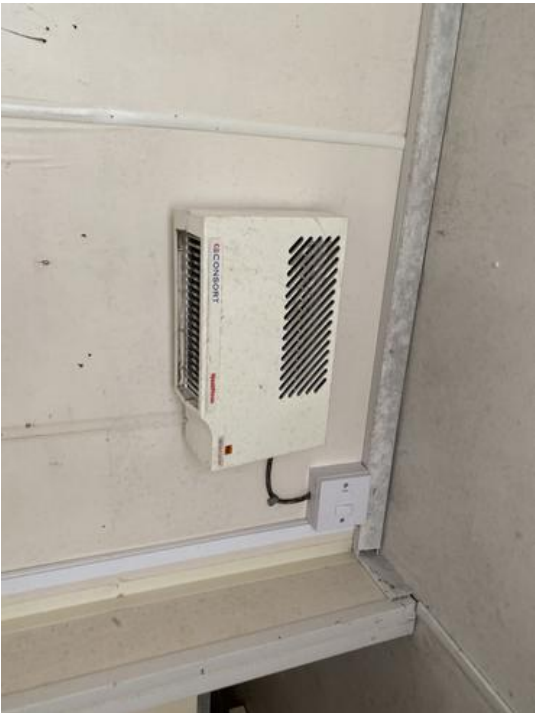
Photo 9	
<b>Number of heaters:</b>	1
Internal	2 / 2 (100%)
<b>Rooms:</b>	2
<b>Floor finish:</b>	Vinyl
<b>Wall finish:</b>	Vinyl faced ply
<b>Kitchen unit:</b>	N/A
<b>Restroom:</b>	Yes
<b>Type:</b>	3 Gents + 1 Ladies

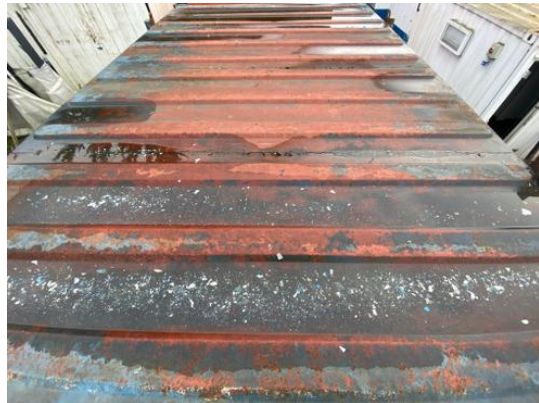
Photo 10		
<b>Score Justification:</b>	Leaking Unt, Rusted roof (cause of leak not visible)	
<b>Paint</b>		Poor
<b>Score justification:</b>	Flaky, showing age, old layer's of paint are visible	
<b>Walls</b>		Good
<b>Floor Beams</b>		Good
<b>Windows</b>		N/A
<b>Shutters</b>		N/A
<b>Doors</b>		Fair
Difficult to open/close		
<b>Keys</b>		Yes
<b>How many keys per lock are included?</b>		2
<b>General Condition</b>		Poor
<b>Score justification:</b>	Roof is in bad condition, signs of leaks showing from inside, (stains on ceiling)	
<b>Overall External Assessment Summary</b>	Unit showing age, Leaky roof

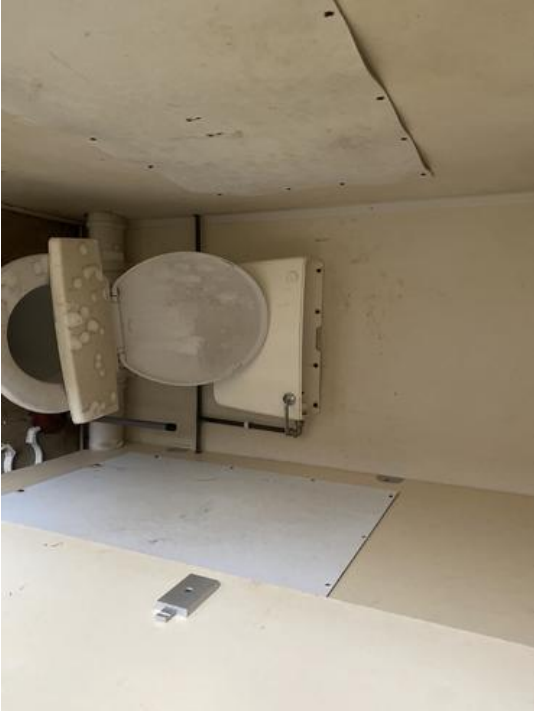
**Handwash Basin**

Bad

Damaged

Photo 11	
<b>Handwash Basin</b>	Bad
Damaged	
<b>Urinals</b>	Good
<b>Water heater</b>	Good
<b>Electrics</b>	Good
<b>General Condition</b>	Bad
<b>Score justification:</b>	Leaky ceiling, damp floor
<b>Overall Internal Assessment Summary</b>	Unit is not water tight, showing age
