Unit Assessment Sheet

**2309209 32ft x 10ft Used AV
Open Plan Office**

Floor finish:	Vinyl
Wall finish:	Plasterboard
Kitchen unit:	No
Restroom:	Yes
Type:	Other
2 Cubicals	
General	
Fleet No. Supplier:	A655305
Fleet No. JCPSA:	2309209
Transport Company:	Other
Date:	09.11.2023 09:17 GMT
Assessed by:	Allan Galwas

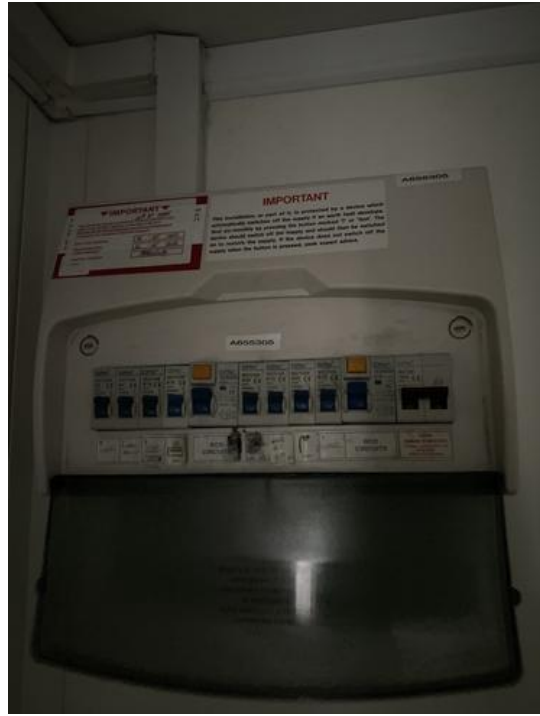
Photo 14

Power in: **Isolator switch**

Consumer unit: **8 Way**

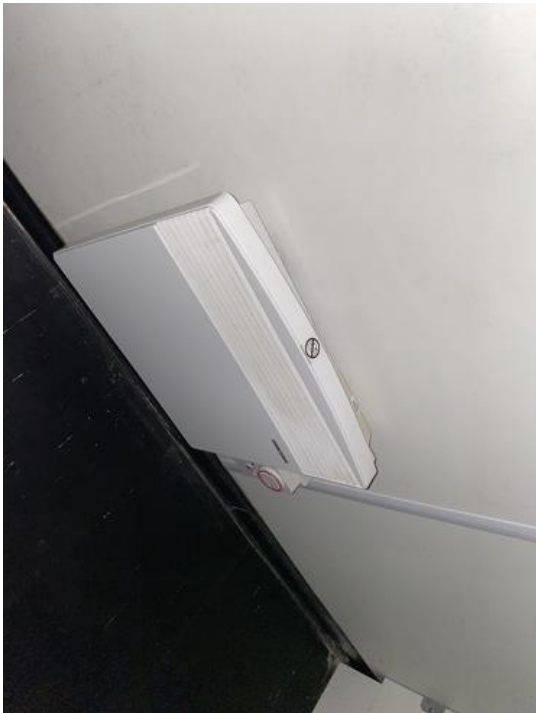
Photo 15

Heating:

Number of heaters: **1**

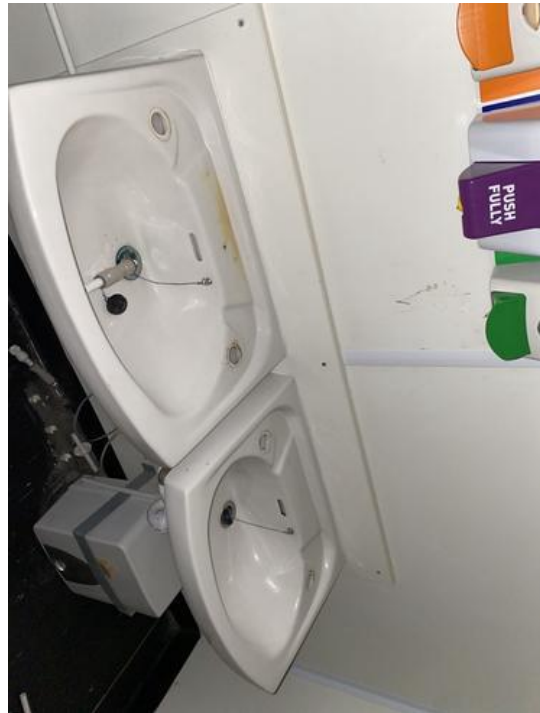
Photo 16

<p data-bbox="185 1393 277 1417">Photo 16</p>	
Urinals	N/A
Water heater	Good
Electrics	Good
General Condition	Good
Overall Internal Assessment Summary	Clean inside, window needs re-fitting
