# Unit Assessment Sheet

2309213 13ft x 9ft Used AV 2+1 Toilet Block

| <b>Date:</b> | 05.10.2023 07:36 BST |

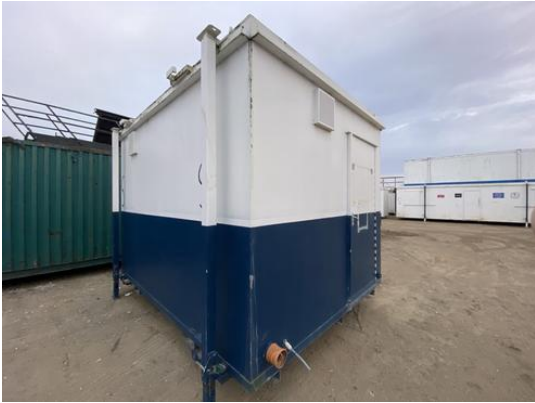
Photo 1

## 2-4 External Pictures of Unit

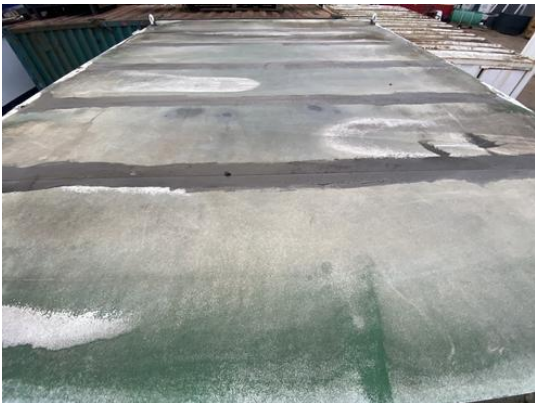
Photo 5

| <b>External Inspection</b> | | 1 flagged, 18 / 25 (72%) |
|--|---|---|
| <b>Overall External Assessment Summary</b> | Unit starting to show some age, no structural damage | |

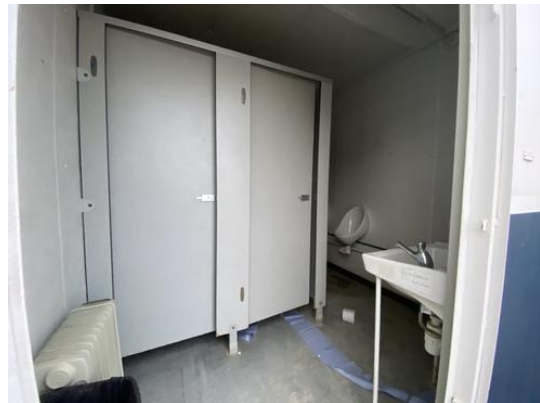
Photo 6

## 2-4 Internal Pictures of Unit

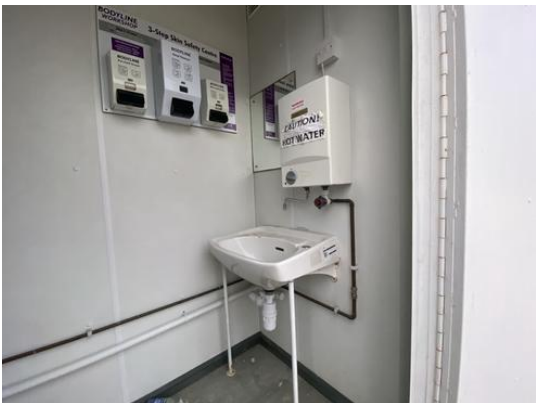
Photo 11

| <b>Overall Internal Assessment Summary</b> | No internal damage |

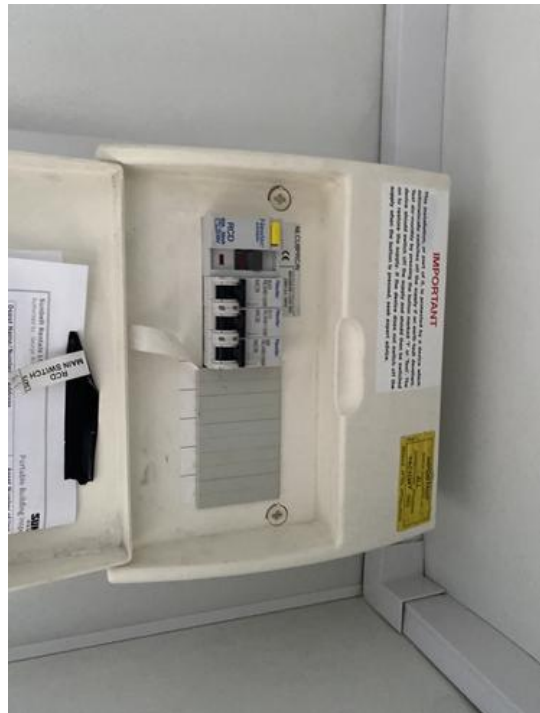
Photo 12

**Consumer unit:**

3 Way

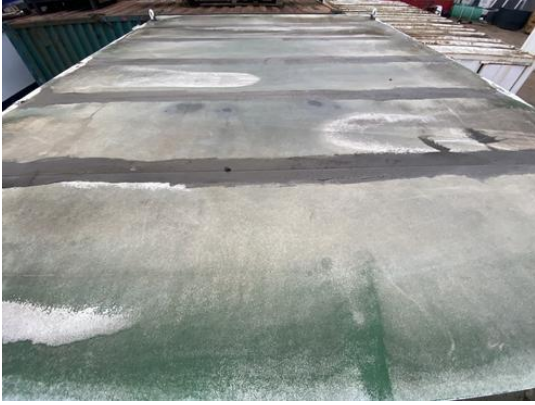
Photo 13

| <b>External Inspection</b> | | 1 flagged, 18 / 25 (72%) |
|--|---|---|
| <b>Roof</b> | | Good |
