# Unit Assessment Sheet

2309214 13ft x 9ft Used AV 2+1  
Toilet Block

Used AV 2+1 Toilet Block

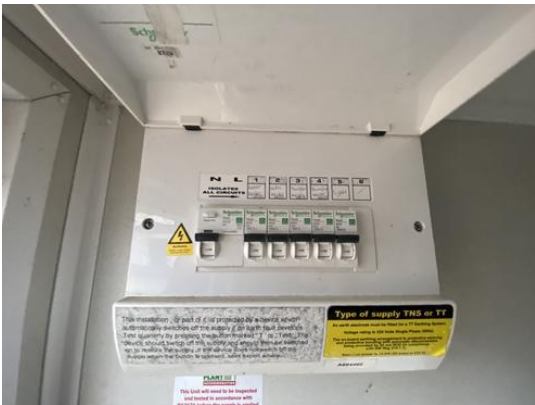
Photo 9

5 Way

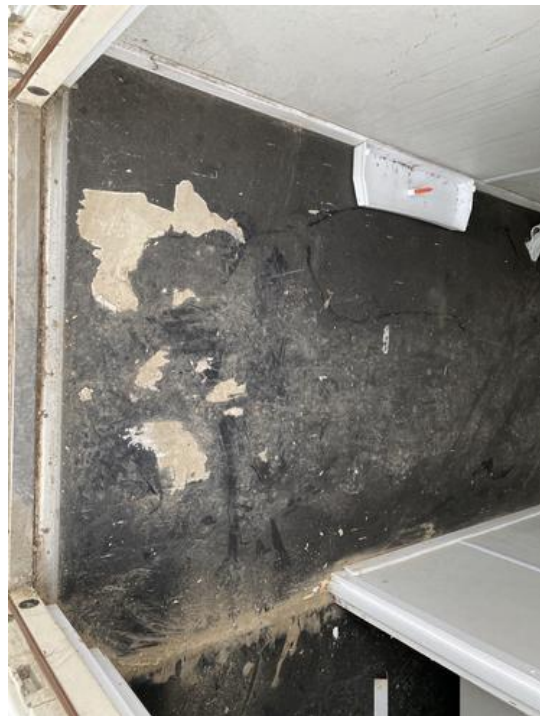
Photo 10

<b>Internal Inspection</b>	40 / 56 (71.43%)
<b>Celling</b>	Good
<b>Walls</b>	Good
<b>Windows</b>	Good
<b>Partition Doors / Keys</b>	Fair
<b>Score justification:</b>	Missing keys 1x external 1x internal
<b>Trims</b>	Good
<b>Floor</b>	Fair
<b>Score justification:</b>	Damaged vinyl

<p>Photo 10</p>	
<b>Other fittings</b>	Toilet
<b>Toilet/WC</b>	Good
<b>Toilet cubicles</b>	Good
<b>Cistern</b>	Good
<b>Handwash Basin</b>	Good
<b>Urinals</b>	Good
<b>Water heater</b>	Good
<b>Electrics</b>	Good
<b>General Condition</b>	Good
<b>Overall Internal Assessment Summary</b>	Floor vinyl slightly damaged
