# Unit Assessment Sheet

**2303106 32ft x 10ft Used AV Office**

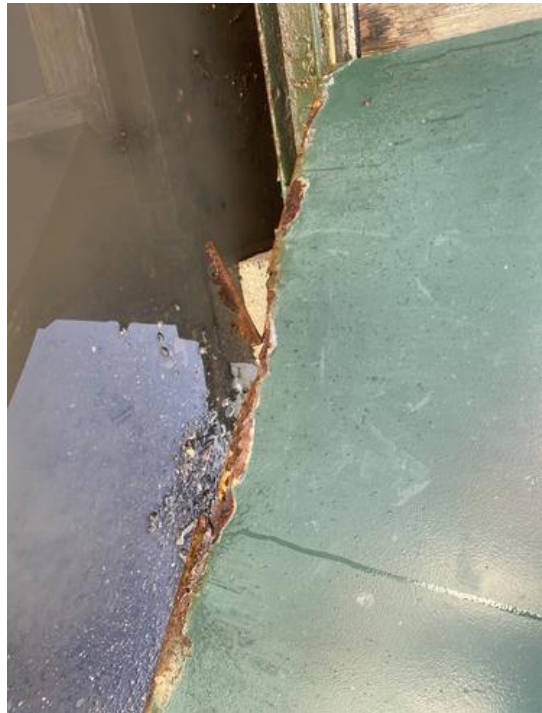
<b>External Inspection</b>		1 flagged, 21 / 33 (63.64%)
Roof		<b>Fair</b>
Score justification:		<b>Rusty, showing age</b>
Paint		<b>Fair</b>
Score justification:		<b>Showing age, starting to lose its colour</b>
Walls		<b>Good</b>
Floor Beams		<b>Good</b>
Windows		<b>Good</b>
Shutters		<b>Good</b>
Doors		<b>Fair</b>
Missing key, damaged/rusty from the bottom

Photo 18		
Keys		<b>No</b>
General Condition		<b>Good</b>
Overall External Assessment Summary		<b>Paint + roof showing age, no signs of leaks.</b>

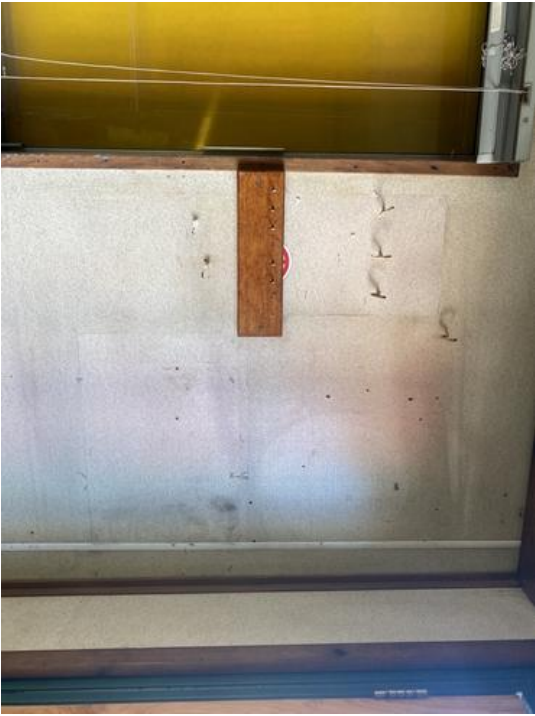
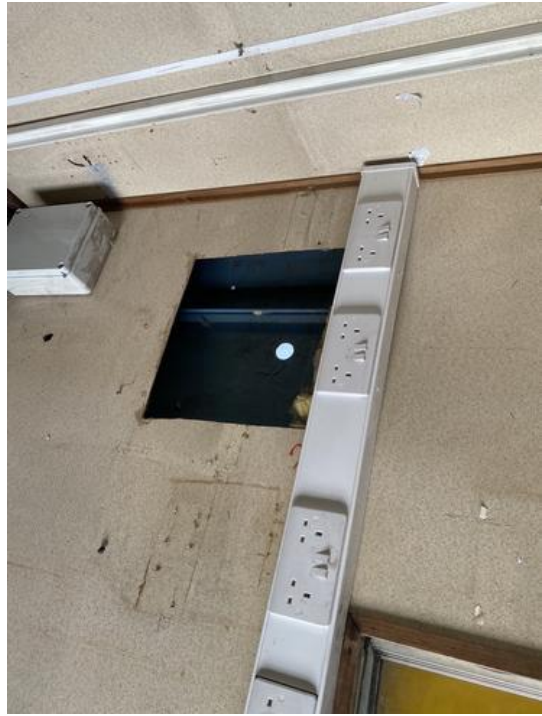
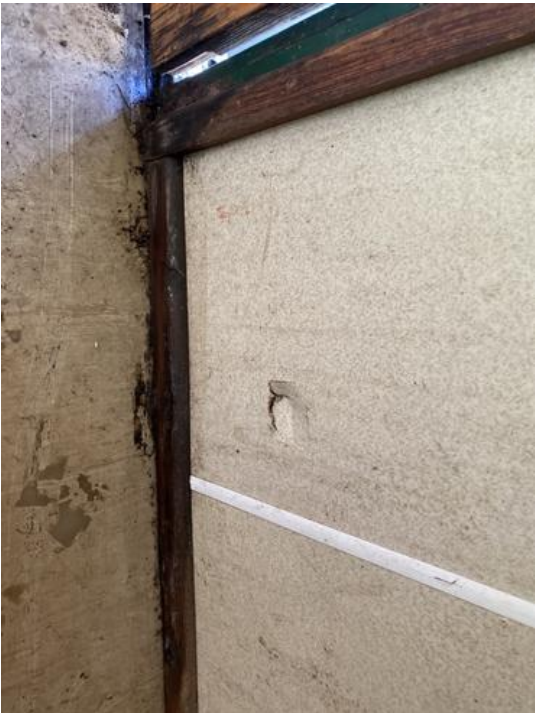
Internal Inspection		35 / 52 (67.31%)
Celling		Good
Walls		Fair
Score justification:	<b>Worn, cut-out, single hole found</b>

Photo 19	Photo 20	Photo 21
Windows		Good
Partition Doors / Keys		Fair
Score justification:	<b>No keys for internal doors, bathroom +entrance door do not close</b>	
Trims		Good
Floor		Fair

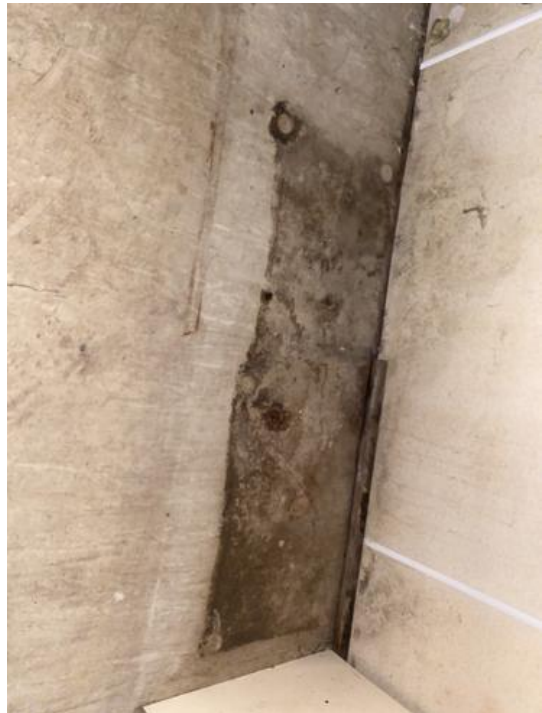
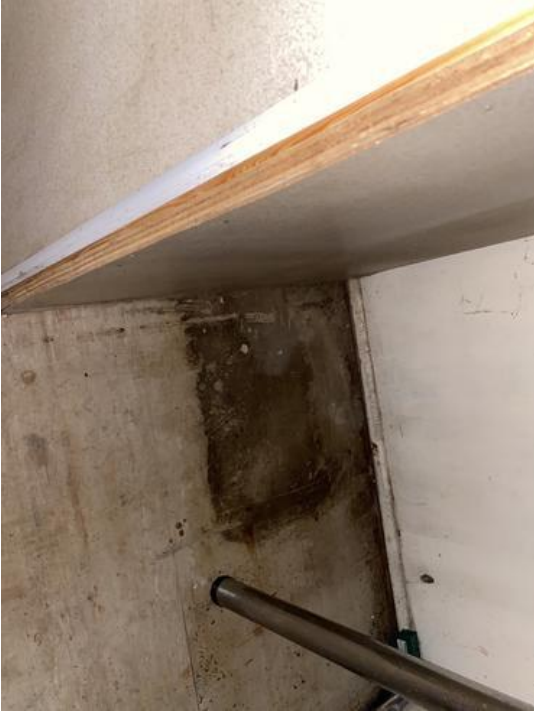
Photo 22	Photo 23	
Score justification:	<b>Stained/worn vinyl</b>	
Other fittings	Kitchen	Toilet
Kitchen unit		Good
Toilet/WC		Good
Toilet cubicles		N/A
Cistern		Fair
