Unit Assessment Sheet

2312247 32ft x 10ft Drying room

Specification: AV Flat Steel Drying Room

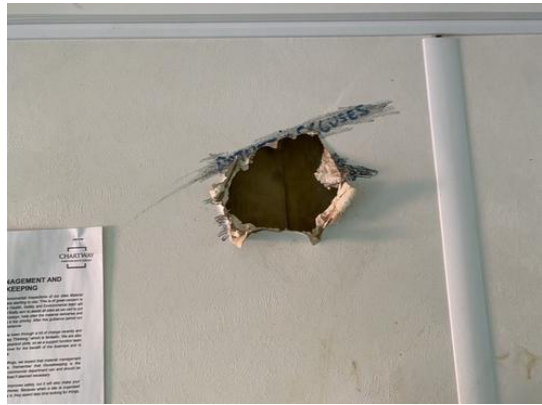
Photo 14

Wall Insulation:

Yes

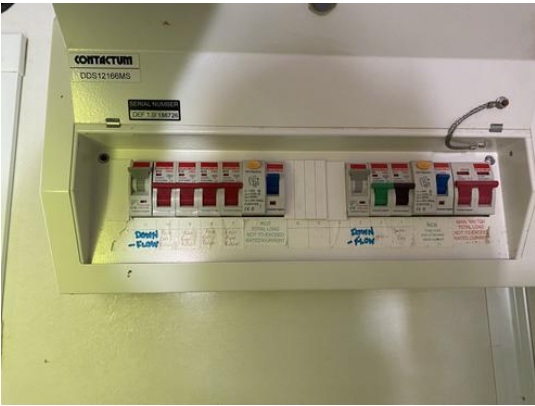
Photo 17

Consumer unit:

12 way

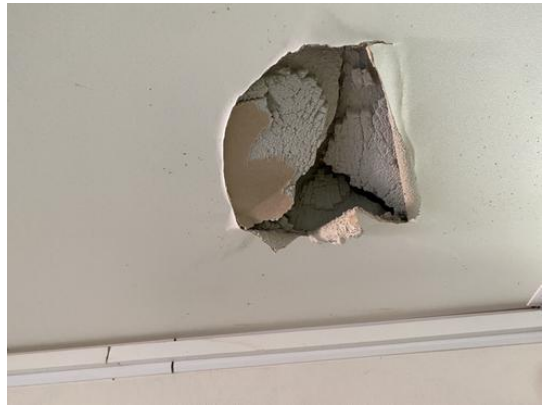
Photo 18

Celling

Fair

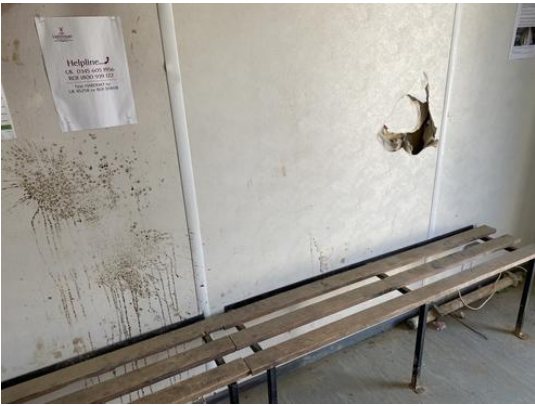
Photo 19

Poor

3 different holes in plasterboard
