# Unit Assessment Sheet

xxxx - 21ft x 9ft AV office

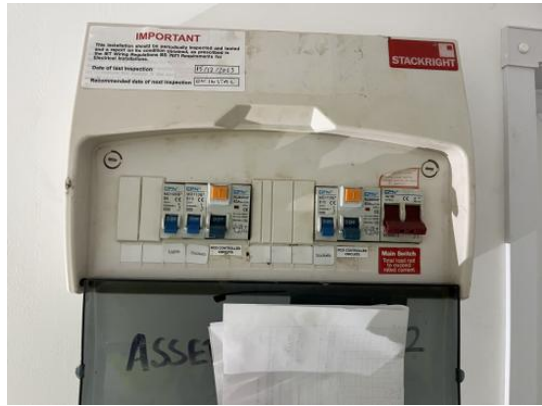
Photo 10

| <b>Consumer unit:</b> | | Yes 7 WAY |
