# Unit Assessment Sheet

2312246 32ft x 10ft Office

03.01.2024 10:45 GMT

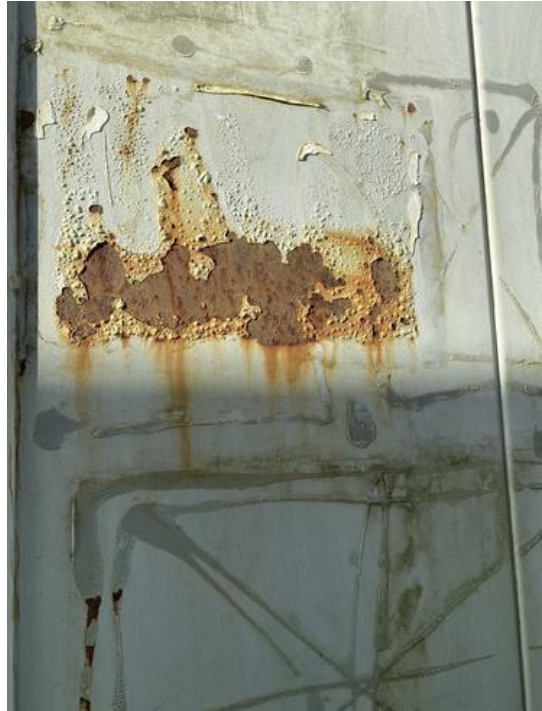
Photo 12

**Paint**

Fair

Fair paint shows age worn

Paint fair shows age no signs of leaks structurally sound

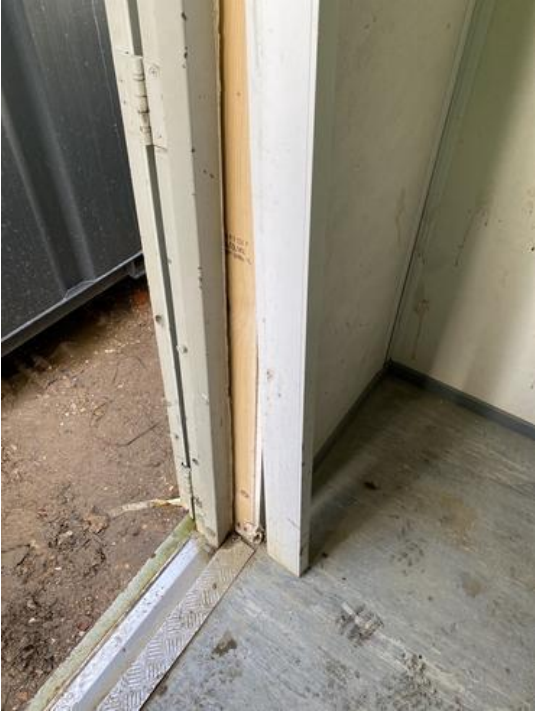
Photo 13

**Doors**

Good

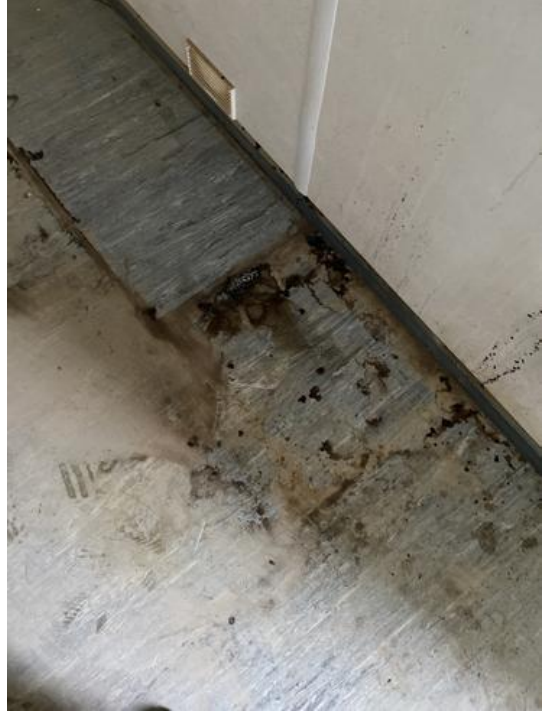
Photo 14	Photo 15
<b>Score justification:</b>	Mould
<b>Other fittings</b>	N/A
<b>Electrics</b>	Good
<b>General Condition</b>	Good
<b>Overall Internal Assessment Summary</b>	Good internal slight mould on floor
