Unit Assessment Sheet

2210364 24ft x 9ft Used AV Store

Jacklegs	Lifting Eye Top
Keys		Yes
How many keys per lock are included?		Yes
One		
Electrical		
Power in:		N/A
Consumer unit:		N/A
Lighting:		Fluorescent light
Number of lights:		1
Number of electrical sockets:		0
Number of electrical switches:		0
Heating:		N/A
Number of heaters:		0
Internal		2 / 2 (100%)
Rooms:		1
Floor finish:		Wood
Wall finish:		Galvanized Steel
Kitchen unit:		N/A
Restroom:		N/A
General		
Fleet No. Supplier:		BBN12215
Fleet No. JCPSA:		2210364
Transport Company:		Other
Date:		20.10.2023 10:40 BST
Assessed by:		Allan Galwas

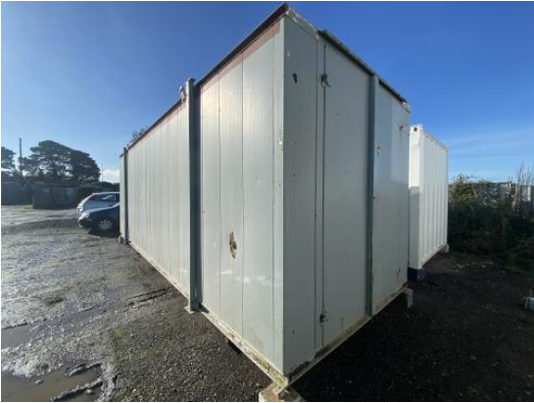
Photo 1

External Inspection		15 / 25 (60%)
Roof		Fair
Score justification:	Restricted access, needs checking	
Paint		Fair
Score justification:	Slightly rusty + chipped	
Walls		Fair
Minor dents		
Floor Beams		Good
Windows		N/A
Shutters		N/A
Doors		Good
Keys		Yes
How many keys per lock are included?		2
General Condition		Fair
Score justification:	Old unit, showing age	
Overall External Assessment Summary	damaged paint + walls, Roof needs to be checked

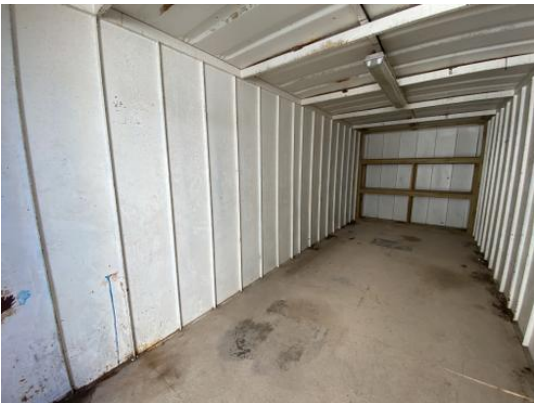
Photo 5

Ceiling Rusted, signs of leak, holes not visible	Fair
---	-------------

water stains all over floor, sign of leak, (unit showing age))

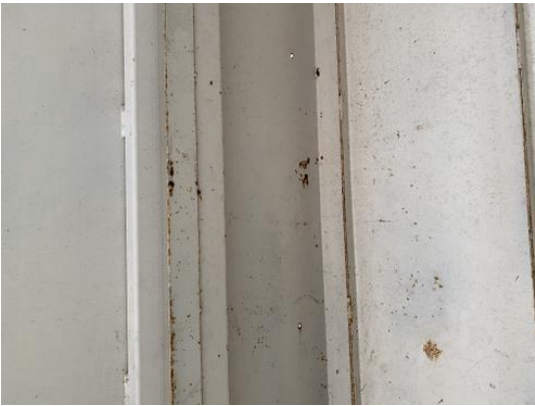
Photo 9

Walls

Score justification:	Tiny holes in certain places
----------------------	-------------------------------------

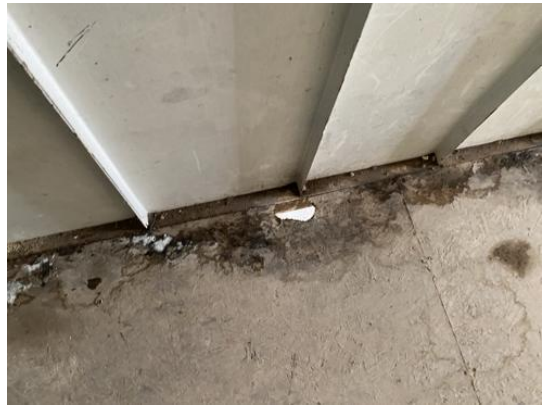
Photo 10

Floor

Score justification:	Hole in floor
----------------------	----------------------
