Unit Assessment Sheet

2302011 32ft x 10ft Used AV
Drying Room

Used AV Drying Room

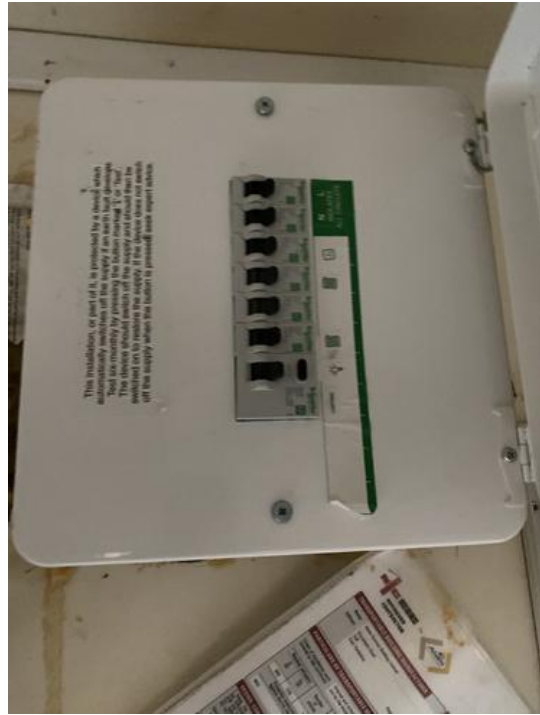
Photo 10

Power in:

Junction box

Consumer unit:

7 Way

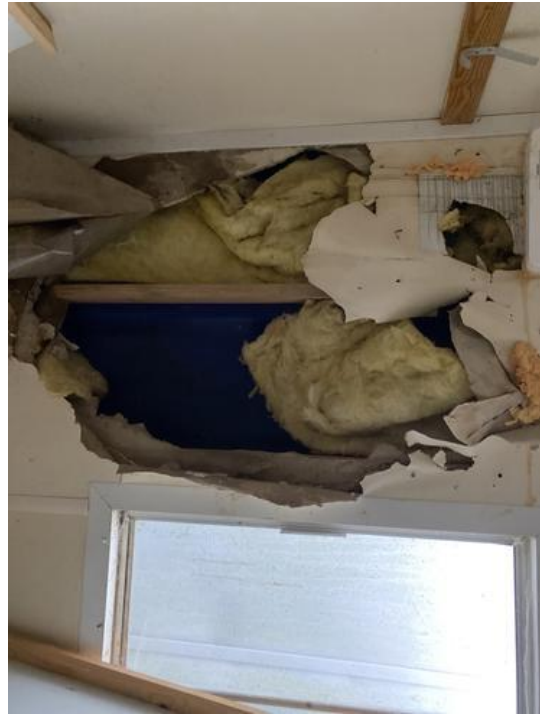
Walls

Bad

Photo 12	
Score justification:	Damaged wall panel + insulation
Windows	Good
Partition Doors / Keys	N/A
Trims	Fair

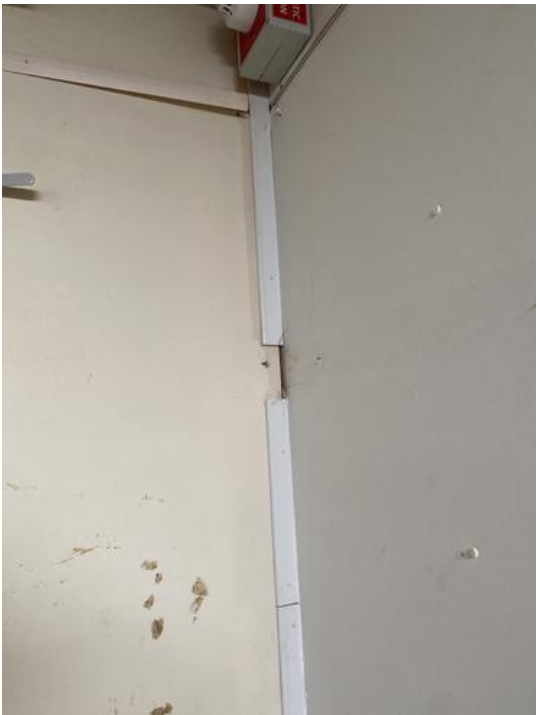
Photo 13	
Score justification:	Tiny piece missing
Floor	Bad
Score justification:	Big crack in the floor, floor is elevated

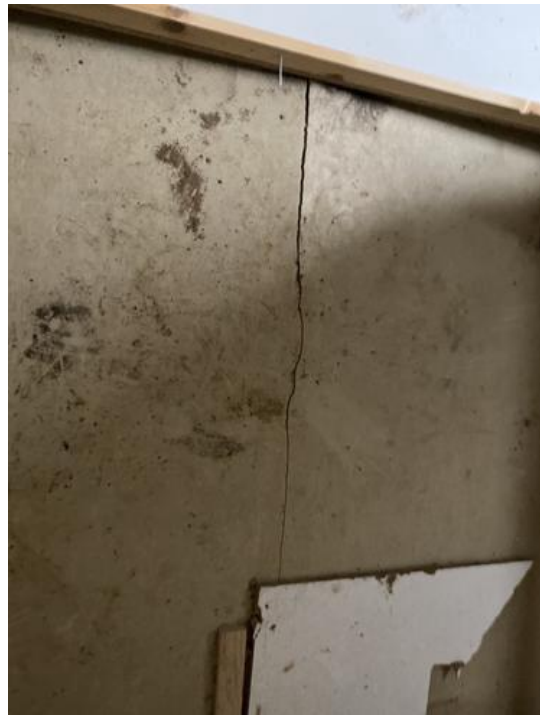
Photo 14	
Other fittings	N/A
Electrics	Good
General Condition	Fair
Score justification:	Damaged floor + wall
Overall Internal Assessment Summary	Structurally damaged
