Unit Assessment Sheet

2302032 21ft x 9ft Used AV Dryer

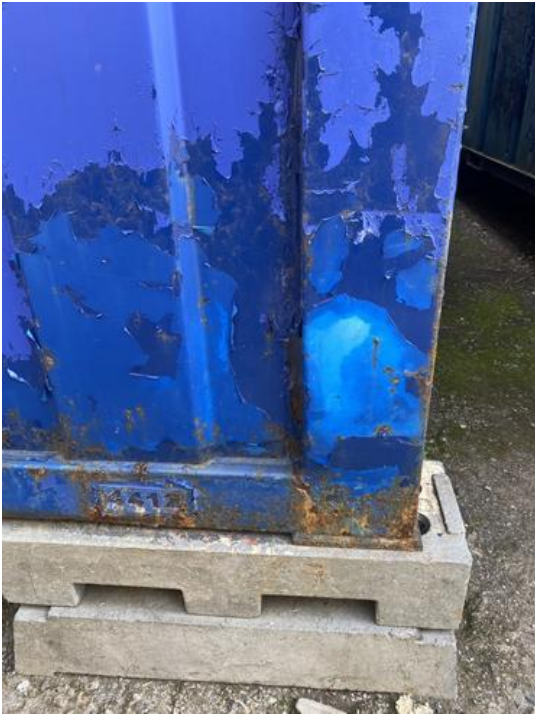
Photo 11

<p>Photo 11</p>	
Score justification:	Rusty + losing its colour
Walls	Good
Floor Beams	Good
Windows	Good
Shutters	N/A
Doors	Fair
Keys	No
General Condition	Fair
Score justification:	Damaged paint + rusty
Overall External Assessment Summary	No structural damage, cosmetically damaged

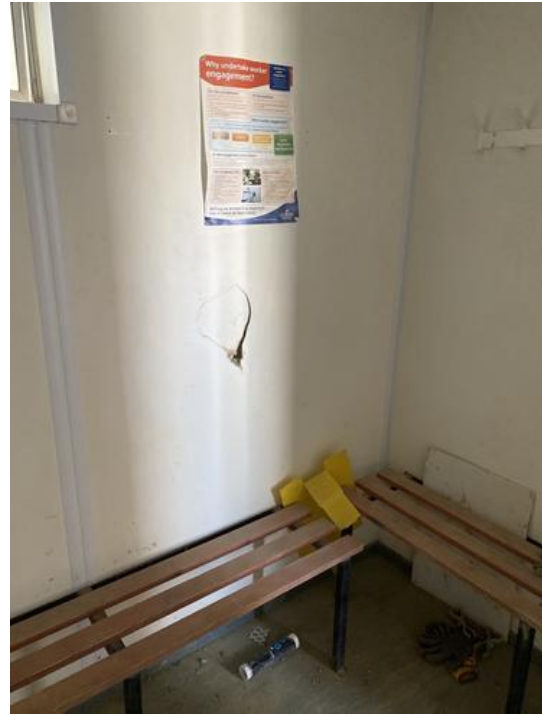
Photo 12	
Score justification:		Hole in the wall
Windows		Good
Partition Doors / Keys		N/A
Trims		Good
Floor		Poor

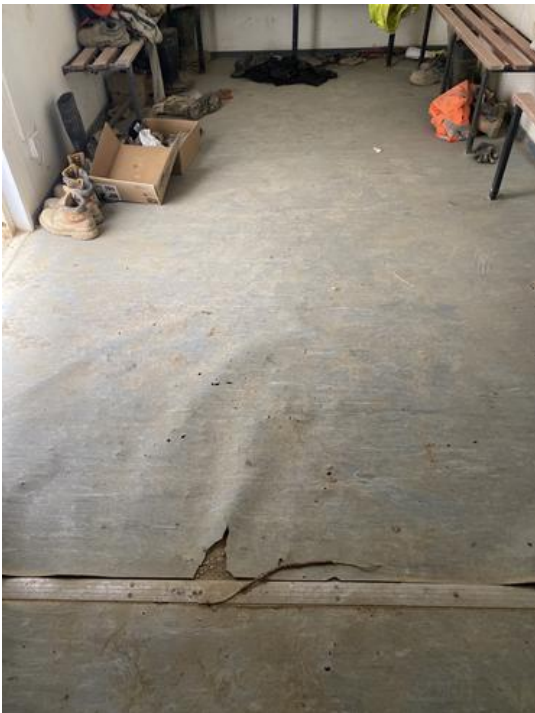
Photo 13	
Score justification:		Vinyl is damaged + has risen leaving bumps
Other fittings		N/A
Electrics		Good
General Condition		Good
Overall Internal Assessment Summary		Internal wall damaged + damaged floor
