Unit Assessment Sheet

2307159 12ft x 9ft Used 2+1 Toilet Block

Used 2+1 Toilet Block

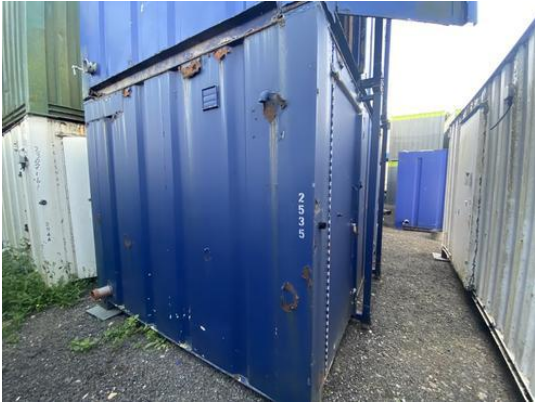
Photo 1

External Inspection	18 / 25 (72%)
Roof	Good
Paint	Fair
Score justification:	Aged + rusty
Walls	Good
Floor Beams	Good
Windows	N/A
Shutters	N/A
Doors	Good
Keys	Yes
How many keys per lock are included?	1
General Condition	Good
Overall External Assessment Summary	Aged + Rust on walls

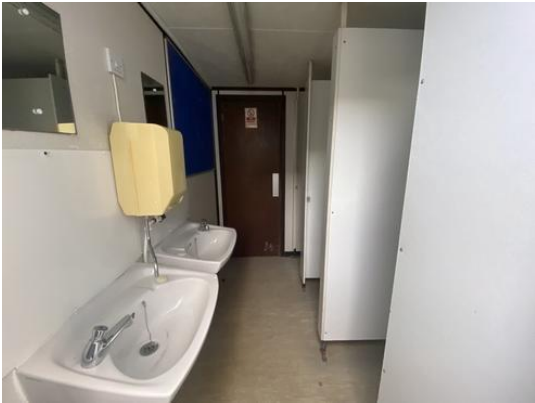
Photo 5

Internal Inspection	39 / 52 (75%)
Ceiling	Good
Walls	Good
Windows	N/A
Partition Doors / Keys	Good
Trims	Good
Floor	Good
Other fittings	Toilet
Toilet/WC	Good
Toilet cubicles	Good
Cistern	Good
Handwash Basin	Good
Urinals	Good
Water heater	Good
Electrics	Good
General Condition	Good
Overall Internal Assessment Summary	Clean + no internal damage
