Unit Assessment Sheet

2307168 20ft x 9ft Used 4+1 Toilet Block

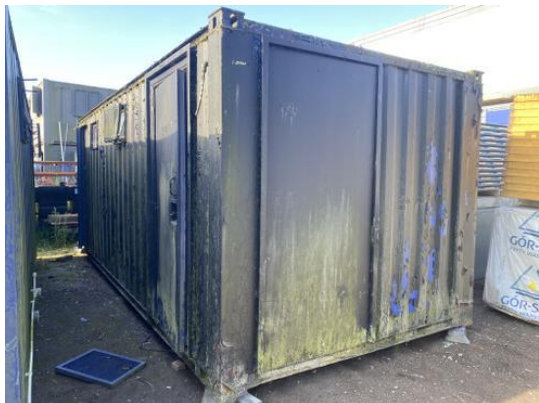
Photo 1

2-4 External Pictures of Unit

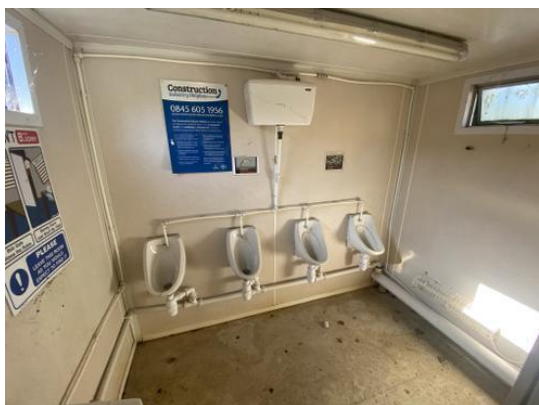
Photo 5

2-4 Internal Pictures of Unit

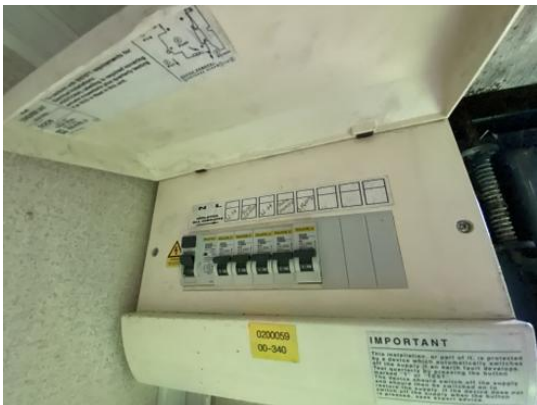
Photo 11	
Lighting:	Fluorescent light
Number of lights:	3
Number of electrical sockets:	0
Number of electrical switches:	0
Heating:	N/A
Number of heaters:	0
Internal	2 / 2 (100%)
Rooms:	2
Floor finish:	Vinyl
Wall finish:	Vinyl faced ply
Kitchen unit:	N/A
Restroom:	Yes
Type:	4 Gents + 1 Ladies
General	
Fleet No. Supplier:	2714
Fleet No. JCPSA:	2307168
Transport Company:	Other

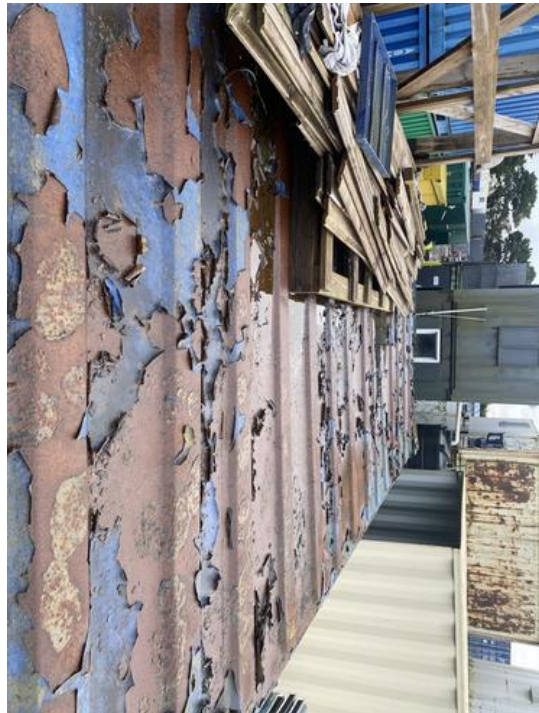
External Inspection	1 flagged, 9 / 29 (31.03%)
Roof	Bad

Photo 12	
Score justification:	Extremely rusty, high chance of leakage
Paint	Bad
Score justification:	Flaky paint, covered in moss & grime, old layer of paint on show.
Walls	Good
Floor Beams	Good
Windows	Poor
Score justification:	Missing window
Shutters	N/A
Doors	Poor
Both missing keys	
Score justification:	Internal side of door damaged, insulation exposed
Score justification:	N/A
Keys	No
General Condition	Poor
Score justification:	Damaged paint, door and a missing window
Overall External Assessment Summary	Unit showing age,, Female toilet is locked (no access) Both doors are missing keys
