Unit Assessment Sheet

2308183 32ft x 10ft Used AV
Open Plan Office

Used AV Open Plan Office

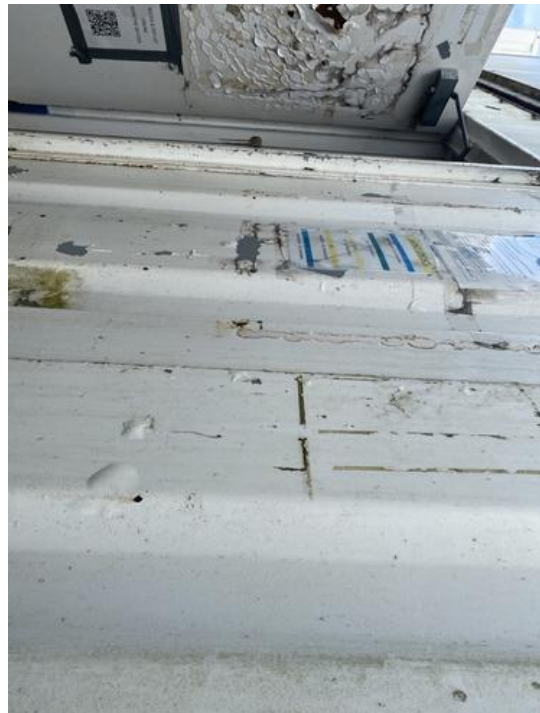
Photo 12

<p>Photo 12</p>	
Score justification:	Paint starting to come off, showing age
Walls	Fair
Floor Beams	Good
Windows	Good
Shutters	Good
Doors	Good
One is locked	
Keys	No
General Condition	Good
Overall External Assessment Summary	Good condition, walls showing age

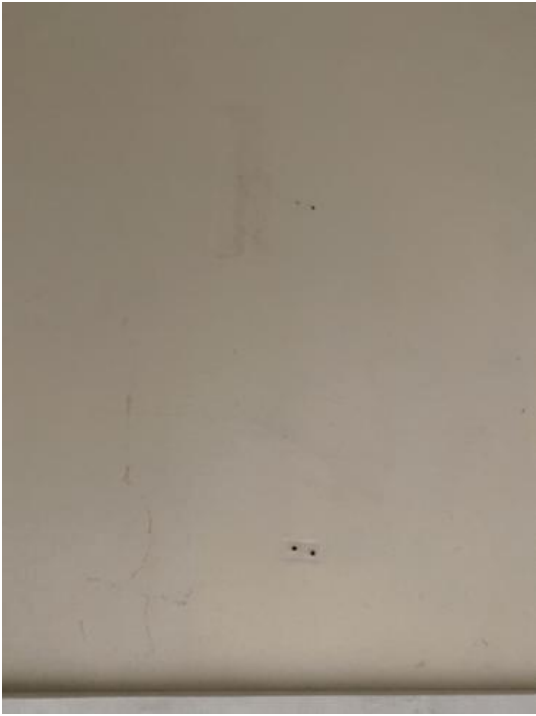
Photo 13

Internal Inspection	17 / 28 (60.71%)
Celling	Good
Walls	Fair
Score justification:	Stained wall panels + small holes all around

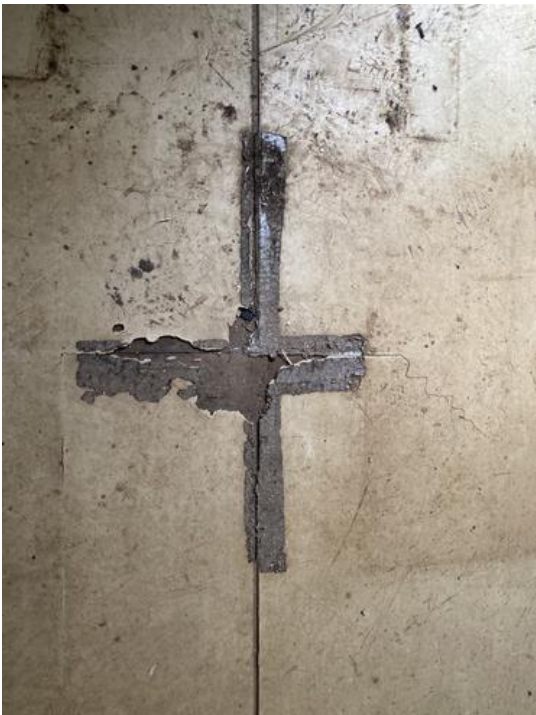
Photo 15

Photo 16	
Score justification:	Extremely rusty + damaged vinyl
Other fittings	N/A
Electrics	Good
General Condition	Fair
Score justification:	Damaged floor , minor defects on the walls
Overall Internal Assessment Summary	Fair condition, structurally good
