Unit Assessment Sheet

2204157 24ft x 9ft AV Office Unit

Restroom:	N/A
General	
Fleet No. Supplier:	BV0660
Fleet No. JCPSA:	2204157
Transport Company:	Other
Date:	17.10.2023 13:21 BST
Assessed by:	Allan Galwas

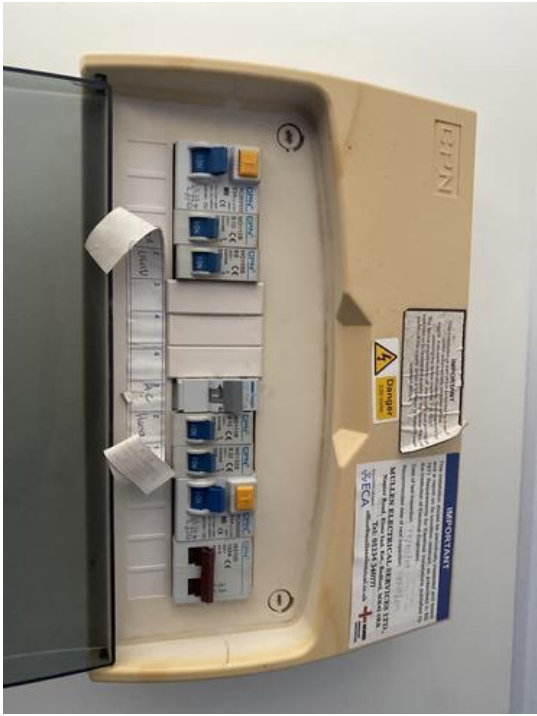
Photo 13	
Lighting:	Fluorescent light
Number of lights:	3
Number of electrical sockets: (Double sockets)	4
Number of electrical switches:	4
Heating:	Convactor heater
Number of heaters:	1
Internal	2 / 2 (100%)
Rooms:	2
Floor finish:	Vinyl
Wall finish:	Plasterboard
Kitchen unit:	Yes
Water heater:	N/A
